Forest
Products
Laboratory

Research
Paper
FPL 381
May 1981

Strength and Stiffness of Small Glued-Laminated Beams with Different Qualities of Tension Laminations

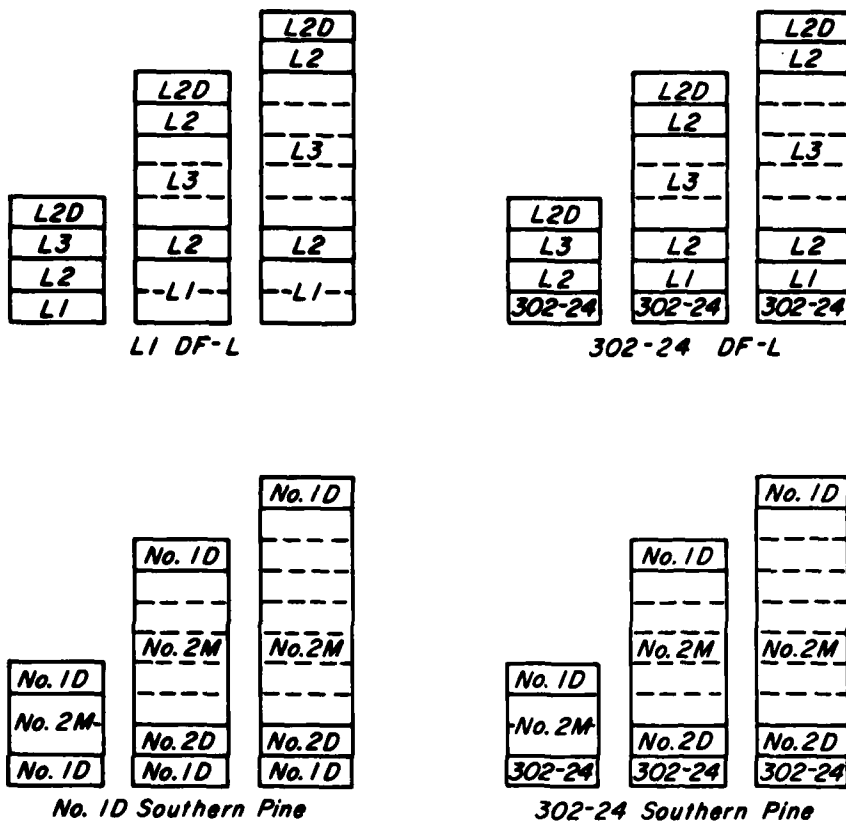
Figure 1.—Test-beam combinations. The DF-L combinations with L1 tension laminations are referred to as L1 DF-L in this report. Similarly, the SP combinations with No. 1D tension laminations are referred to as No. 1D SP. Beam combinations with 302-24 tension laminations are referred to as either 302-24 DF-L or 302-24 SP. (M 148 967)

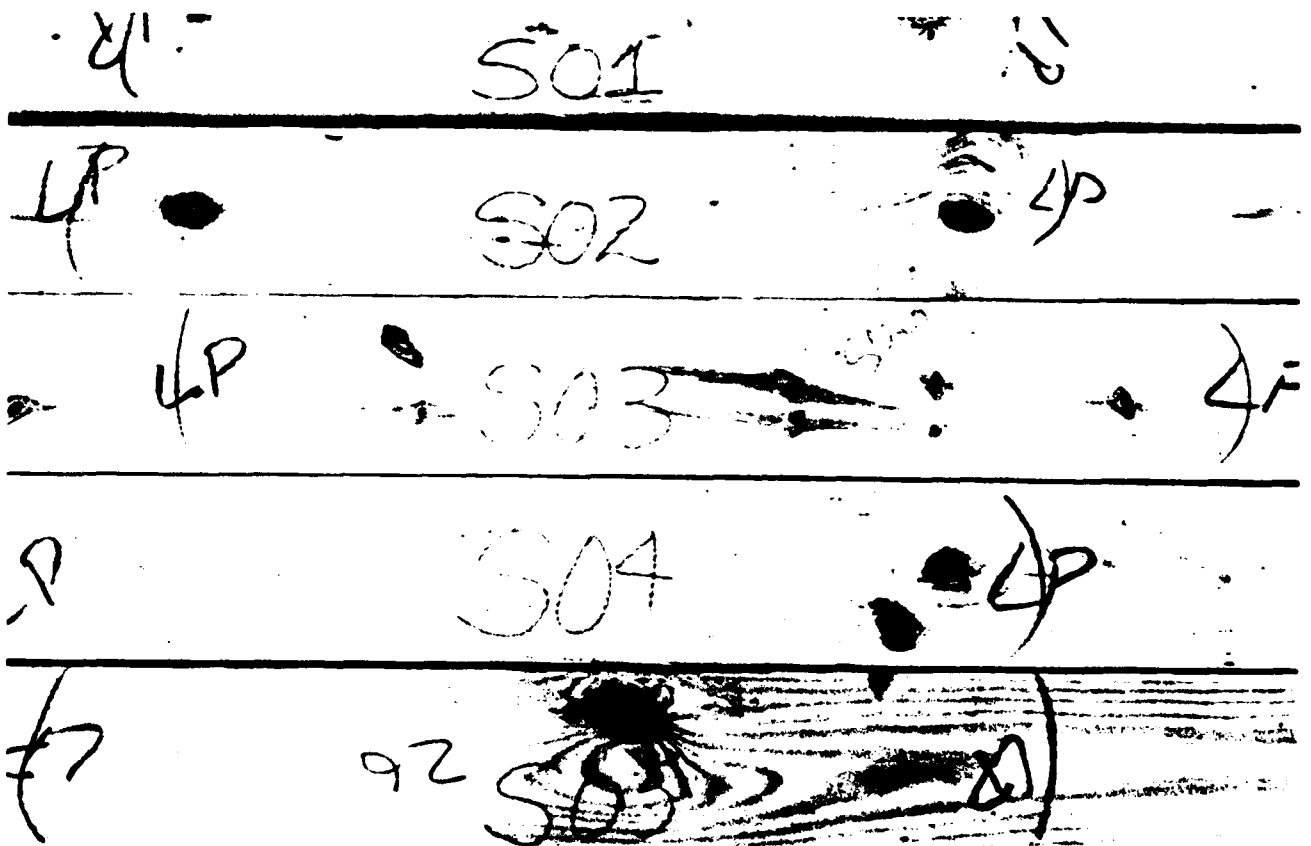
Figure 3.—Some No. 1D SP boards that illustrate the quality of No. 1D tension laminations selected for this study. (M 147 050-11)

Figures 2 and 3 illustrate the typical, near-minimum quality of the selected 302-24 and No. 1D SP tension laminations, respectively. The near-minimum quality of the selected 302-24 and L1 DF-L tension laminations is illustrated in appendix A by figures A-8 and A-9, respectively, which show some of the beam failures.

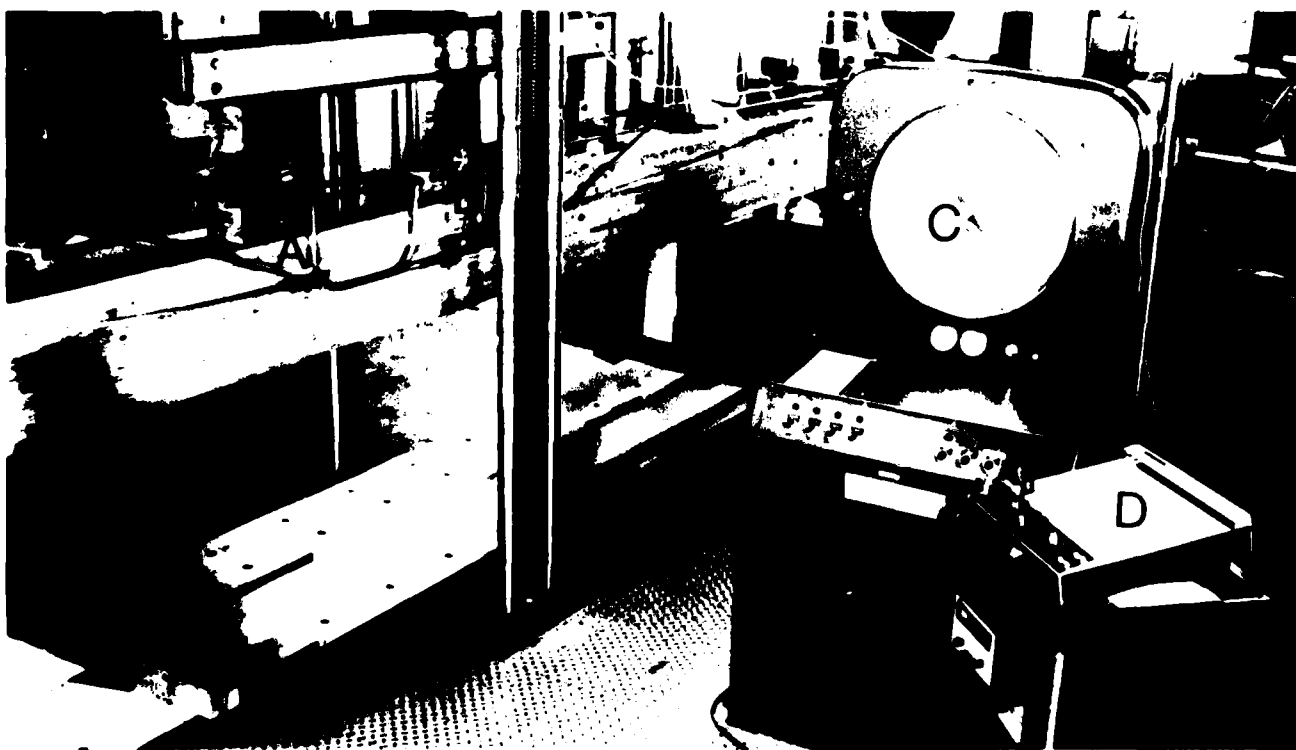
Figure 5.—Close-up view of the equipment used to obtain the required data: A. deflection yoke; B. linear potentiometer; C. Riehle 160,000-pound testing machine; D. x-y recorder.

vided a continuous record of the machine test load versus the full-span deflection (fig. 5). Following failure the moisture content of each lamination was measured near the failure area with a resistance-type meter having 1-1/2-inch-long prongs. The failure area was cut from each beam, photographed, and saved for further inspection.

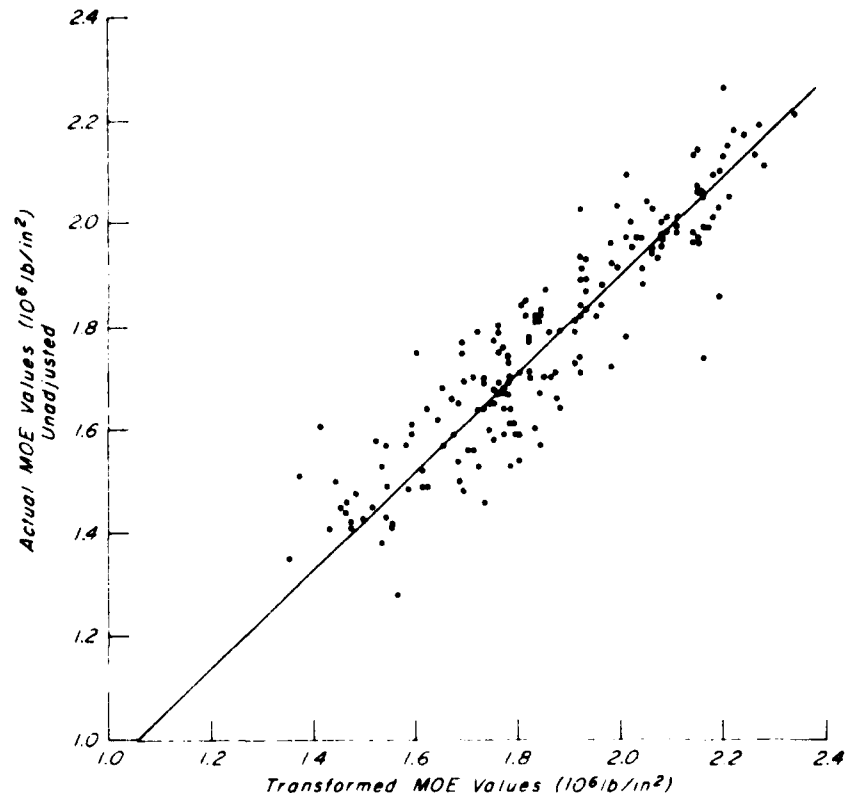
Figure 6.—Comparison of actual and transformed MOE values. Calculations for transformed values were based on actual stiffness of individual pieces of lumber used in the beams.

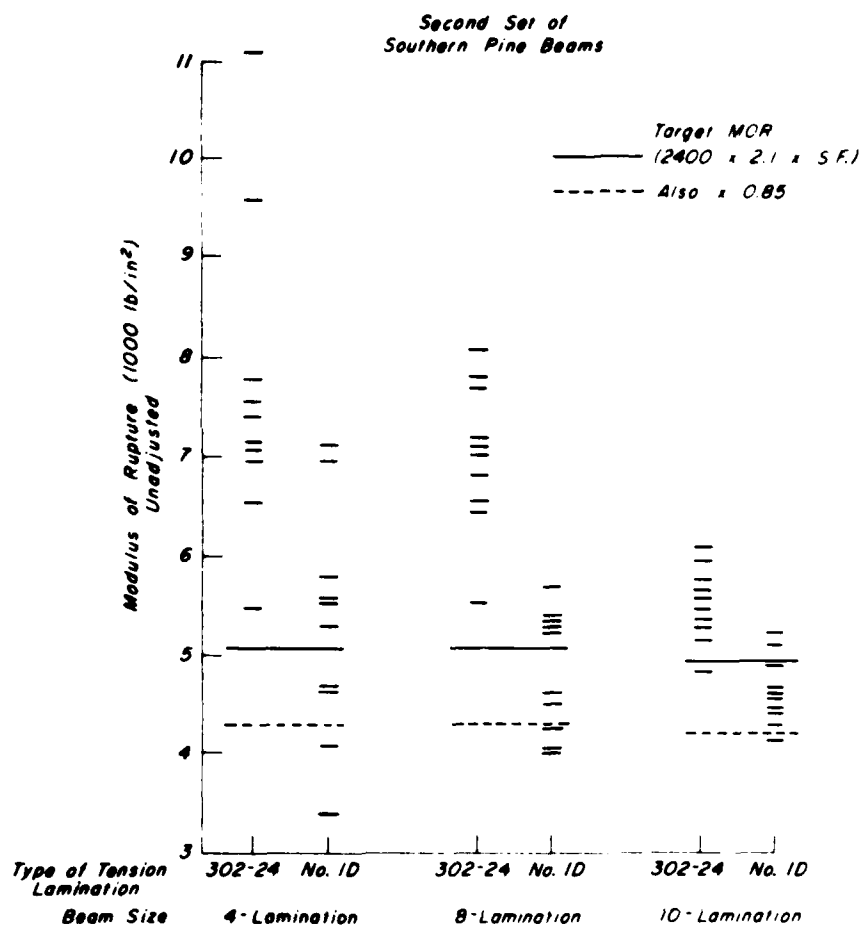
Figure 7.—Comparison of the second set of SP test MOR values with the appropriate target MOR value.

3. Figures 7 and 8 and table 8 show that only two out of 60 302-24 test beams (3 pct) failed below the target MOR level. This is a lower frequency than allowed by the criteria currently used in determining an appropriate design level; that is, one out of 20 beams (5 pct) is allowed to fail below the design stress times 2.1.

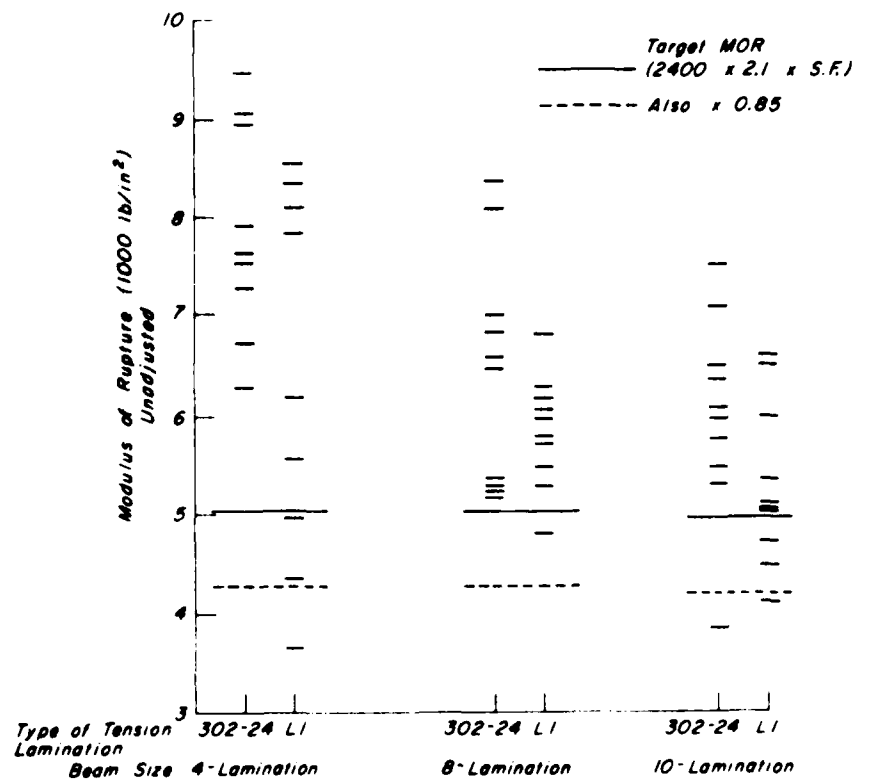
Figure 8.—Comparison of the DF-L test MOR values with the appropriate target MOR value.

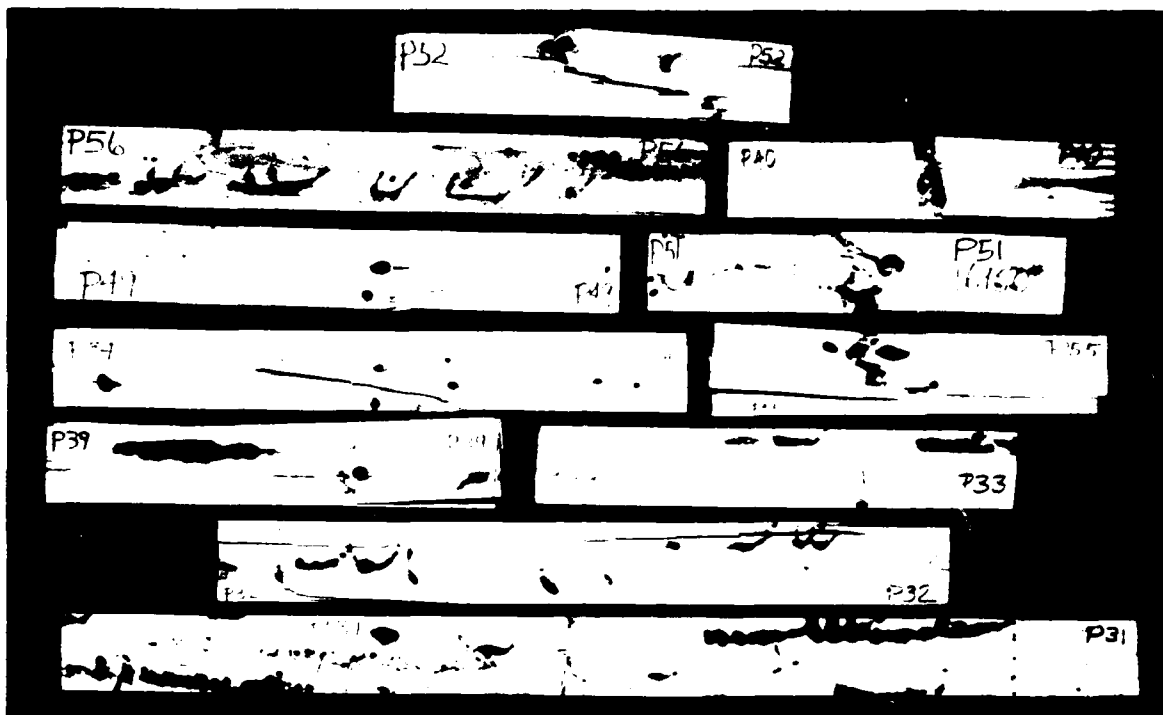
Figure A-3 - Selected failures from the second set of 30/24 SP beams. P52 (top) was the only beam that failed below the target MOR level.

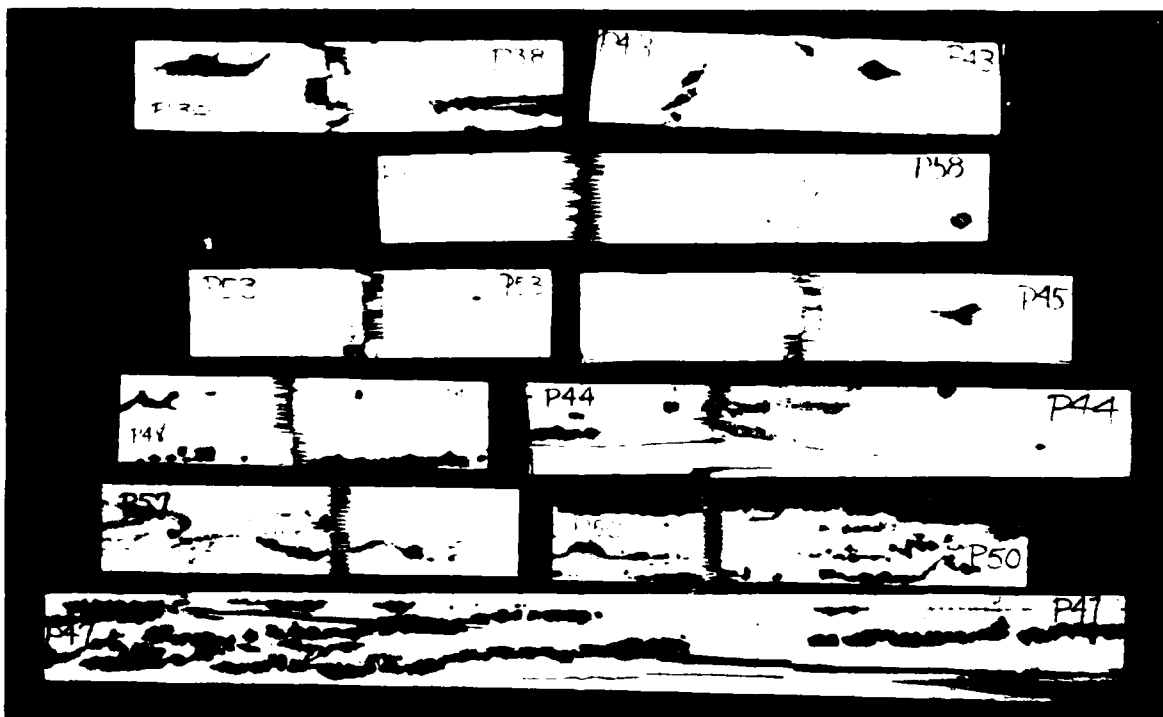
Figure A-4 - Failure sections of the beams from the second set of 30/24 SP beams that had a finger joint involved in the failure. Also illustrated is the typical appearance of the second set of SP finger joint failures.

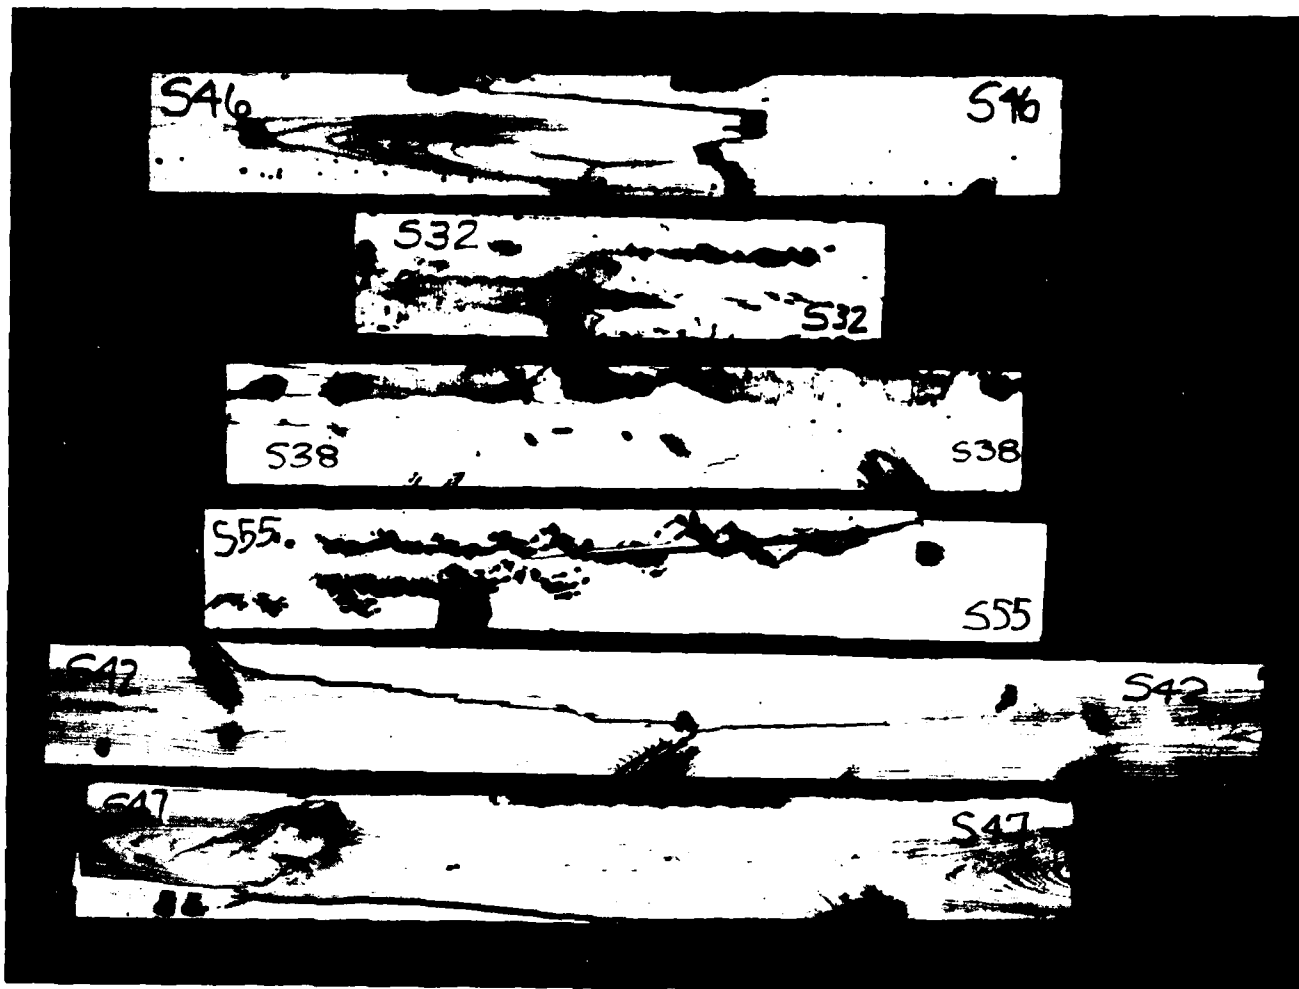
Figure A-5.—Failure sections of the beams from the second set of No. 1D SP beams that failed more than 15 percent below the target MOR level.

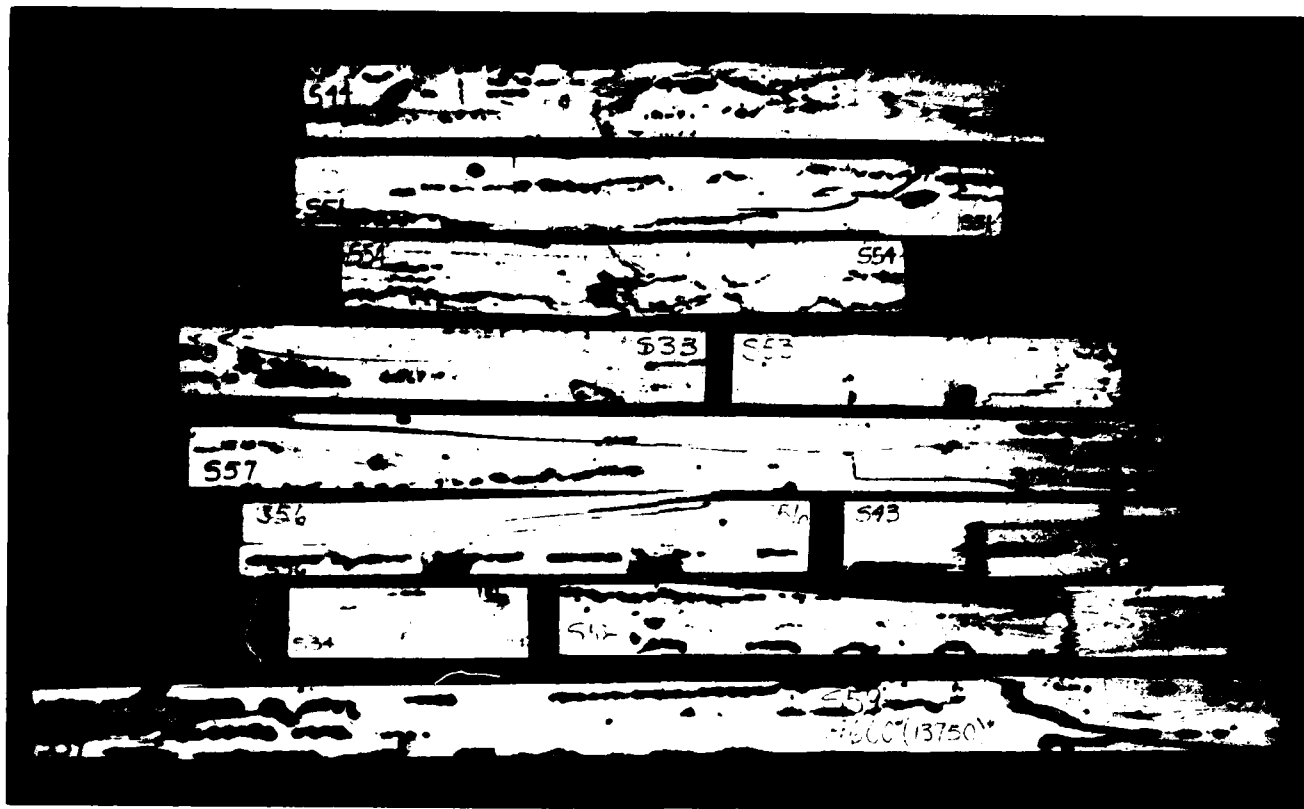
Figure A-6.— Failure sections of the beams from the second set of No. 1D SP beams that failed below the target MOR level, but by less than 15 percent.

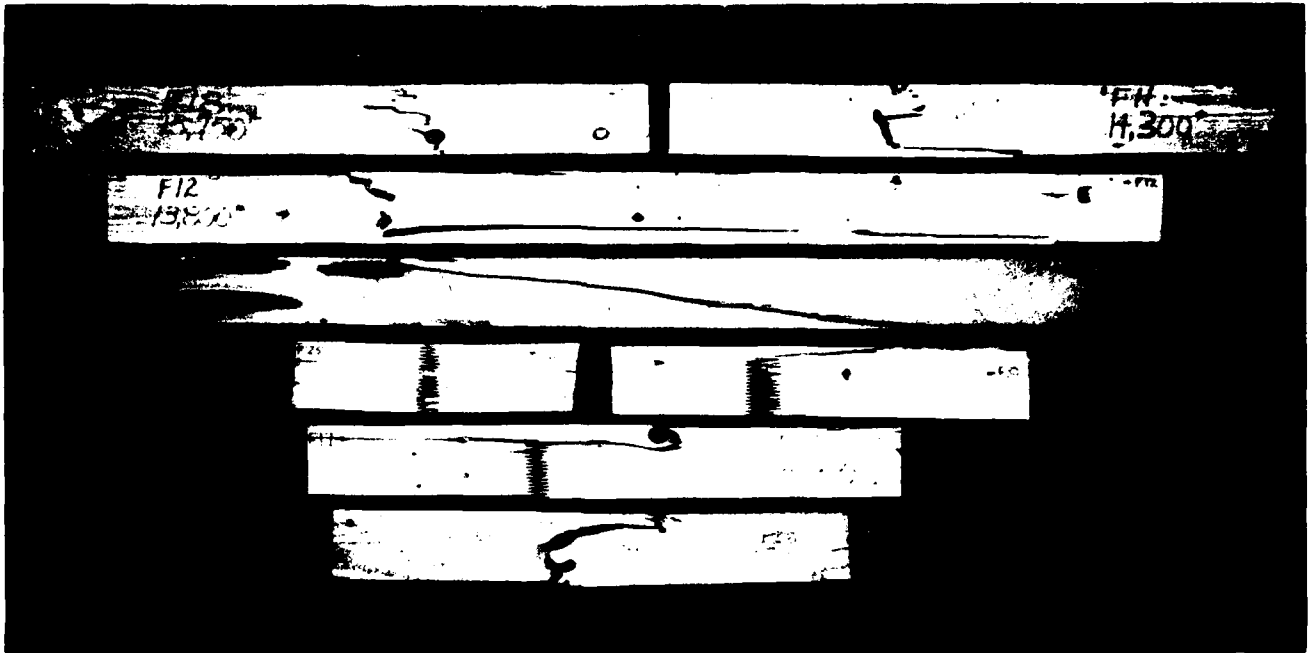
Figure A-7.—Most of these 302-24 DF-L beam failures occurred at a level slightly above the target level. Beam F23 failed below the target level. (M 147 126)

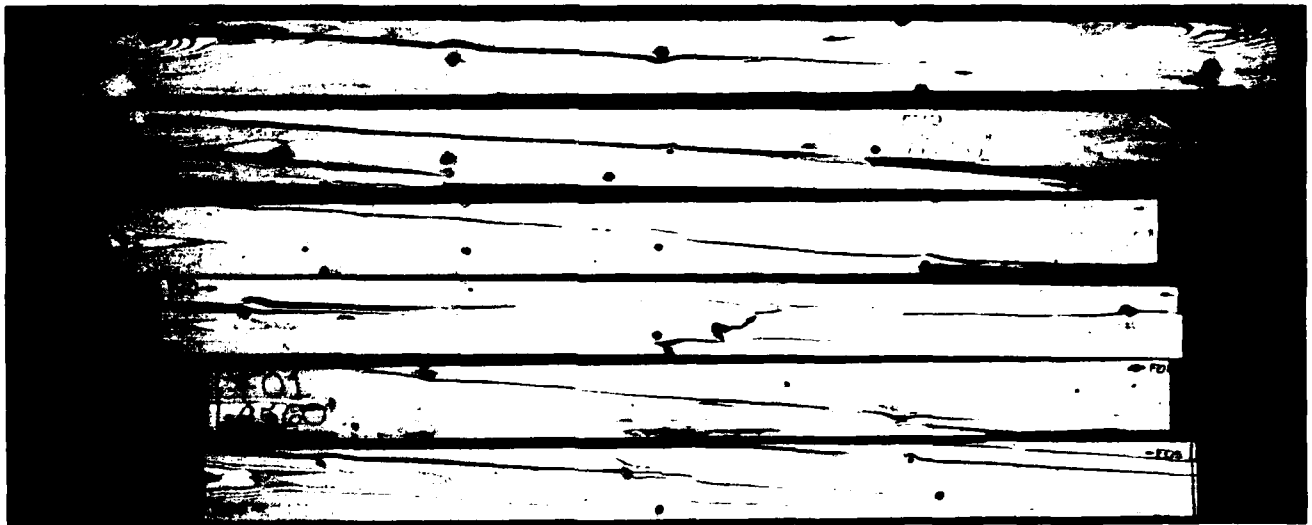
Figure A-8.—These 302-24 DF-L failures illustrate the typical, near-minimum quality of 302-24 tension laminations selected. (M 147 136)

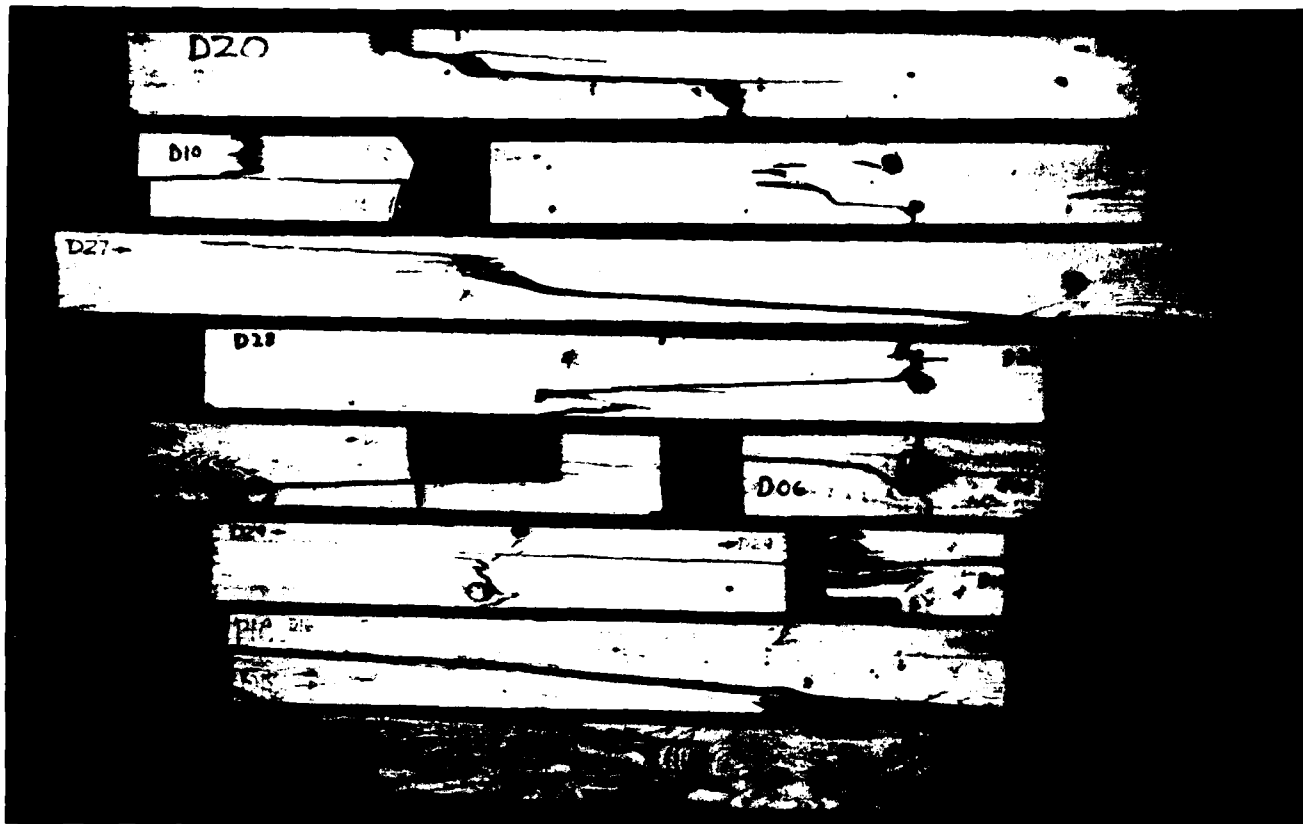
Figure A-9.—All of the below-target L1 DF-L beam failures are shown here along with some selected failures just above the target level. The photograph also illustrates the typical, near-minimum quality of L1 tension laminations selected. (M 147 138)

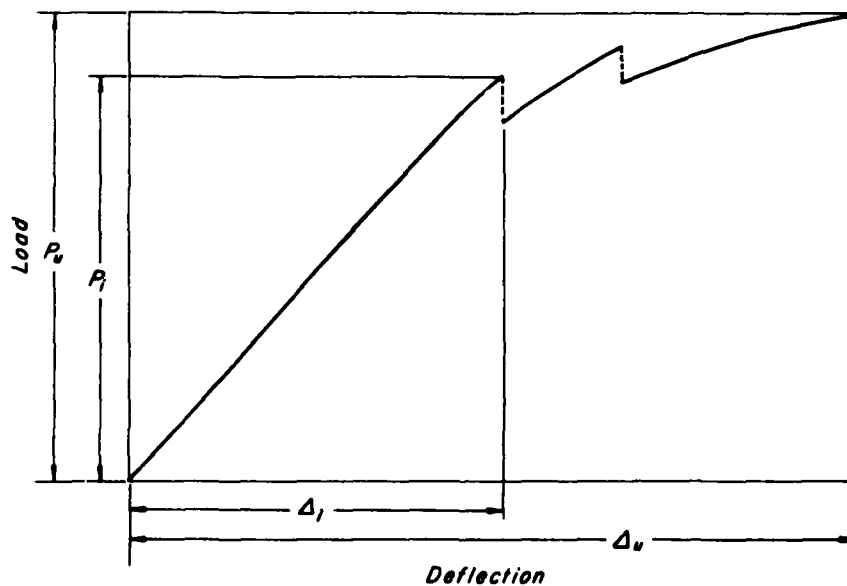
Figure A-10.—A typical example of a load versus deflection curve for a beam that failed gradually. Load (P_i) and deflection (Δ_i) at first failure are shown along with ultimate load (P_u) and deflection (Δ_u). The slope of the initial P- Δ curve is the basis for calculating the modulus of elasticity (MOE). (M 148 953)

Several beams exhibited a gradual type of failure with cracking or splintering of the tension lamination, accompanied by varying amounts of drop in the test machine load. For 20 beams, this drop in load was significant (5 pct or more), and upon further loading the ultimate load exceeded the initial maximum load. For these beams, shown in more detail in appendix A, there is some question as to their possible performance under a true dead load versus the type of load imposed in a screw-type testing machine. However, the ultimate load obtained in the screw-type machine has traditionally been used to calculate the modulus of rupture values, so it was used throughout this study.

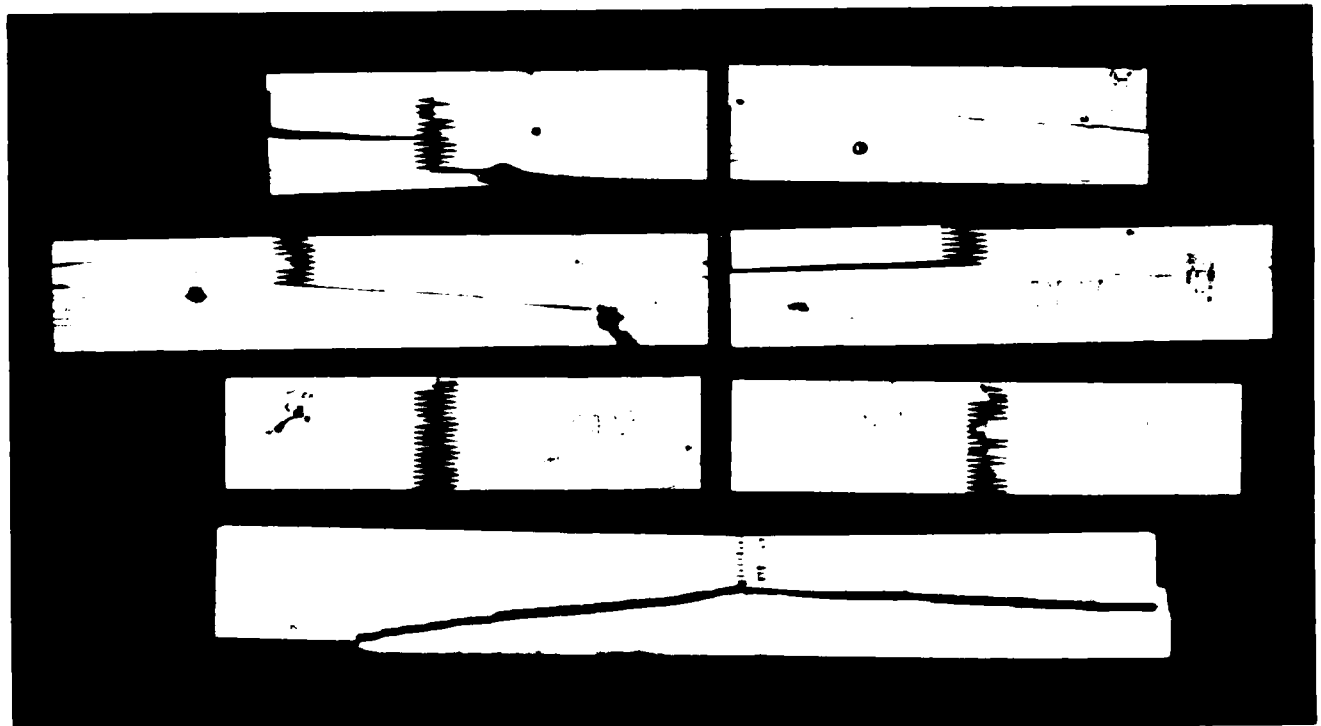
Figure D-1 — Failure sections of seven 302-24 grade tension test specimens.
